OUR MGS

Chipping away at the slow ravages of time

Simon's BGT gets some cosmetic improvements thanks to a new quick-and-easy stone chip repair system, but a mechanical niggles is yet to be cured.

1979 MGB GT

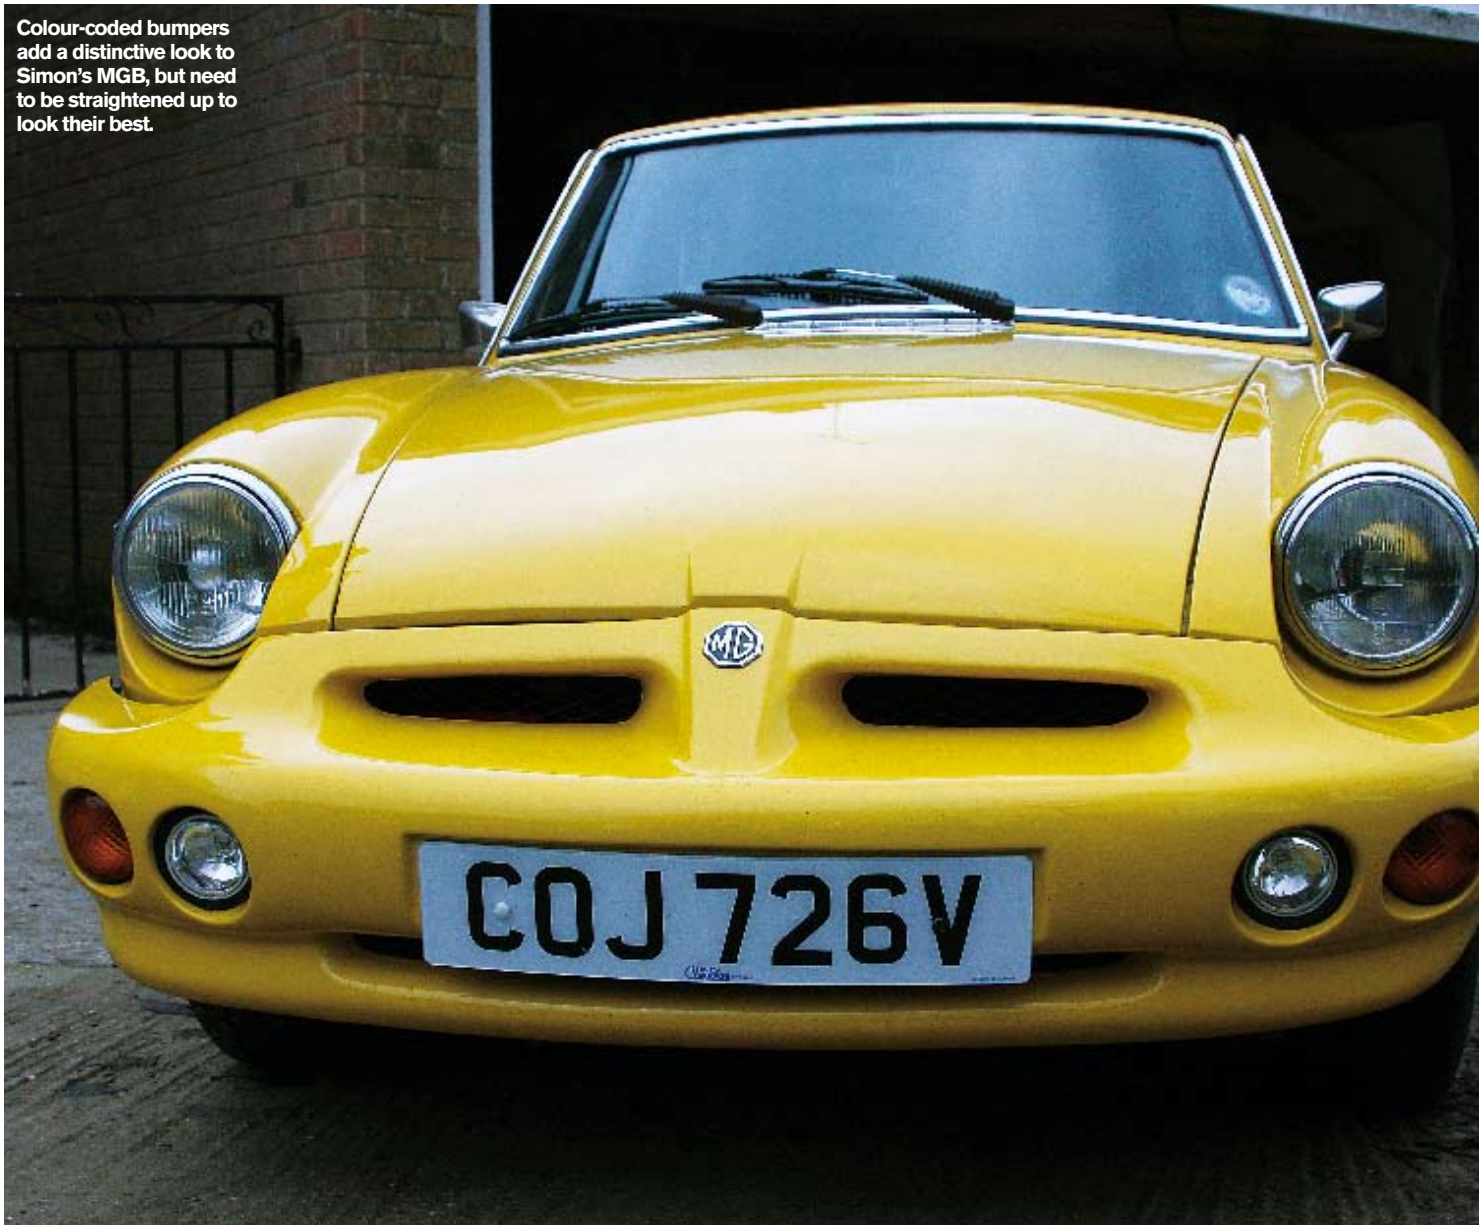
Colour-coded bumpers add a distinctive look to Simon's MGB, but need to be straightened up to look their best.

then you can very quickly cross something off. The front bumper that is sitting slightly low on one side is a good example – this really should take no more than a few minutes to straighten out.

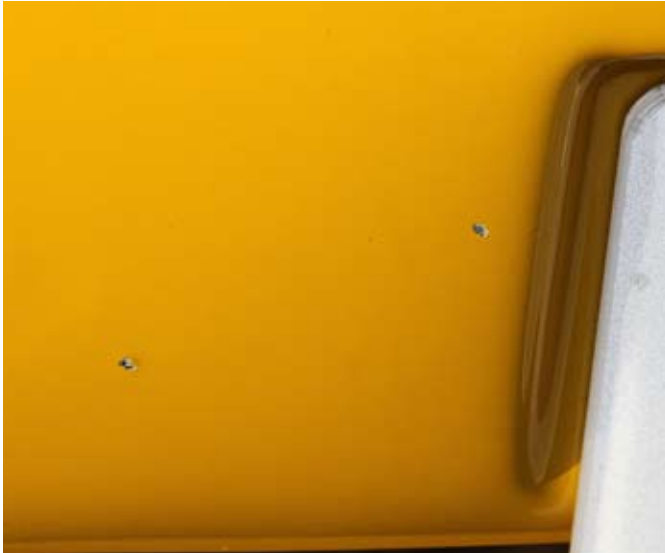
There is no danger of rust on the fibreglass panel, but the proliferation of stone chips was starting to drag down the rest of the car's finish.

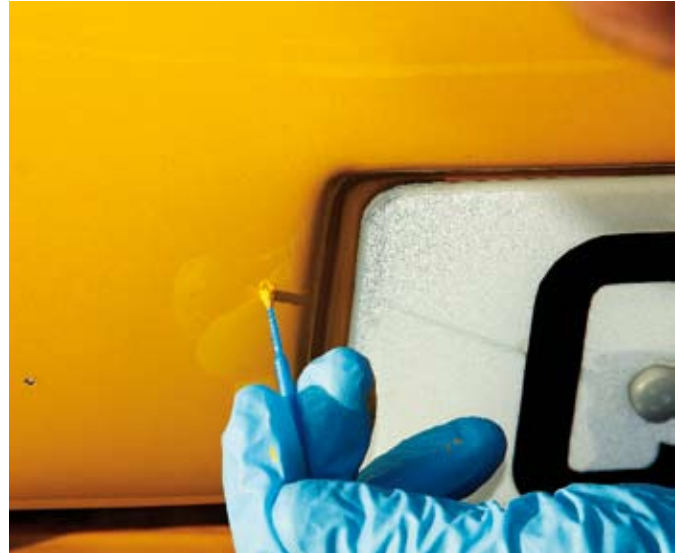
Once you have cleaned the panel, the perfectly matched paint is blobbed into the chip, and dries rapidly – two minutes is all you need for it to set.

area to be treated. You then simply blob the paint onto the stone chip, give it a couple of minutes to dry and then flatten it off with a finger, or the plastic scraper provided in the kit.

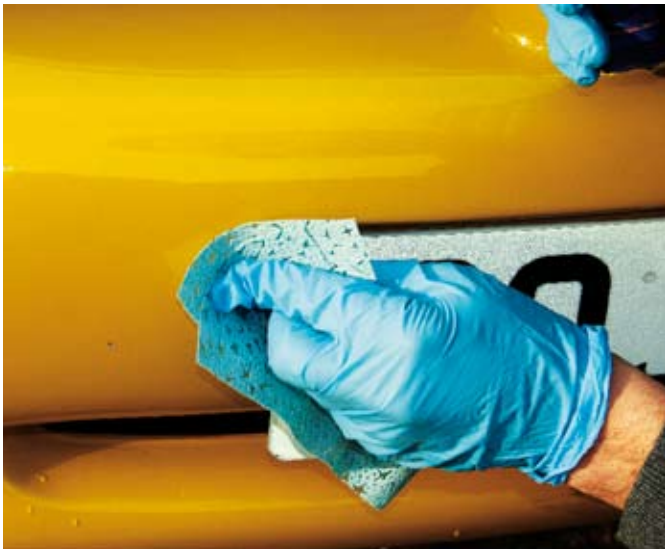
The blending agent then lifts off any excess paint from the panel's surface, leaving the new colour confined within the damaged area.

That is stage one complete. Stage two is to wipe over the painted area using the blending solution from the kit. This lifts off any surplus paint very easily, leaving only the new pigment

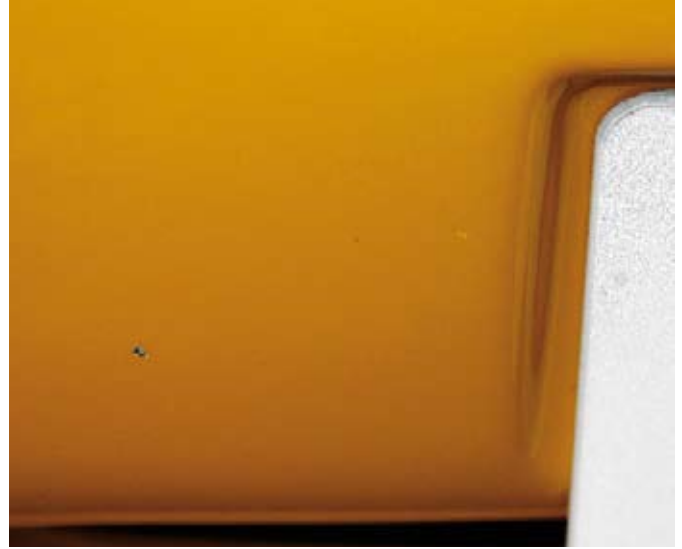
Under the scrutiny of a close-up camera lens you can see where the repair was done, but the chip is all but invisible from a normal viewpoint.

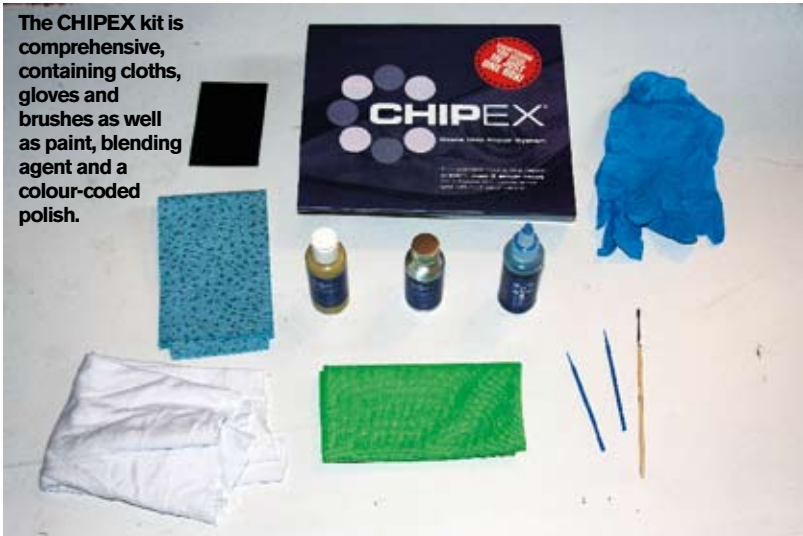
The CHIPEX kit is comprehensive, containing cloths, gloves and brushes as well as paint, blending agent and a colour-coded polish.

The CHIPEX kit costs £49.99, and is pretty comprehensive. You actually get 50ml of paint, which is enough to do a heck of a lot of stone chips! It is not suitable for use with cellulose paints, but is fine with all other types, and that included the two-pack that is now on my car.
