Chipping away at the slow ravages of time

Simon's BGT gets some cosmetic improvements thanks to a new quick-and-easy stone chip repair system, but a mechanical niggles is yet to be cured.

1979 MGB GT

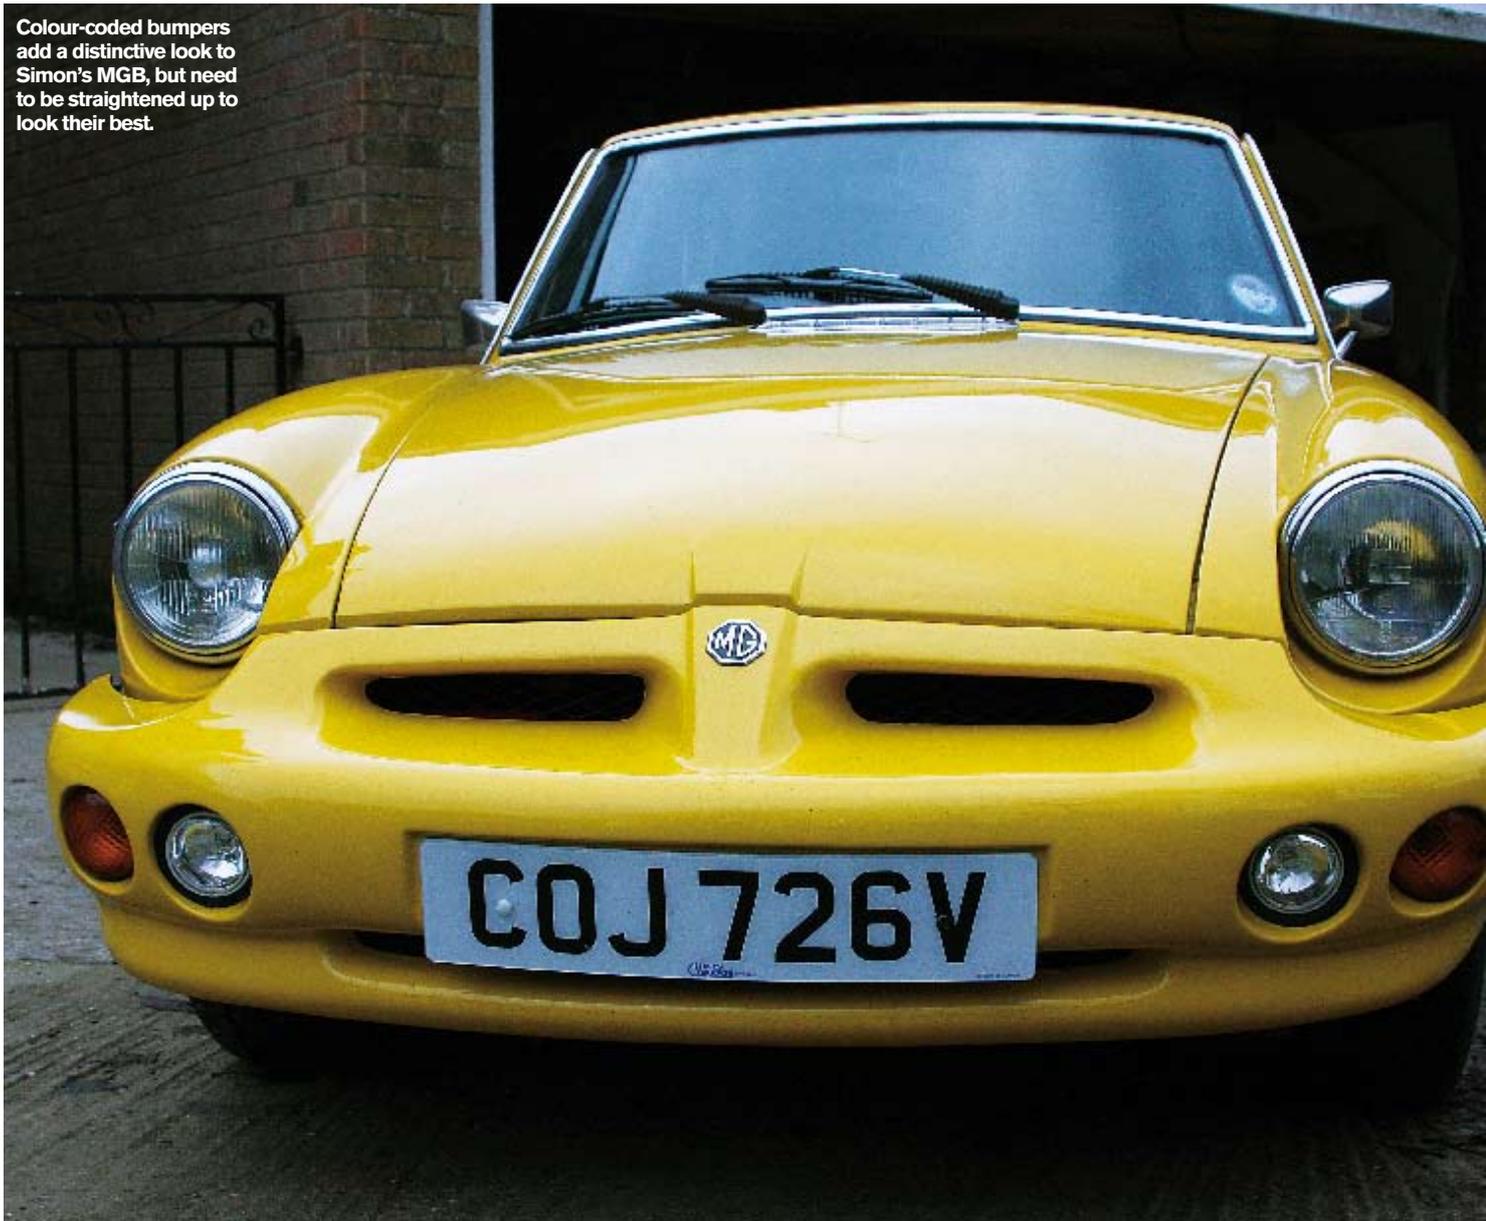
Colour-coded bumpers add a distinctive look to Simon's MGB, but need to be straightened up to look their best.

then you can very quickly cross something off. The front bumper that is sitting slightly low on one side is a good example – this really should take no more than a few minutes to straighten out.

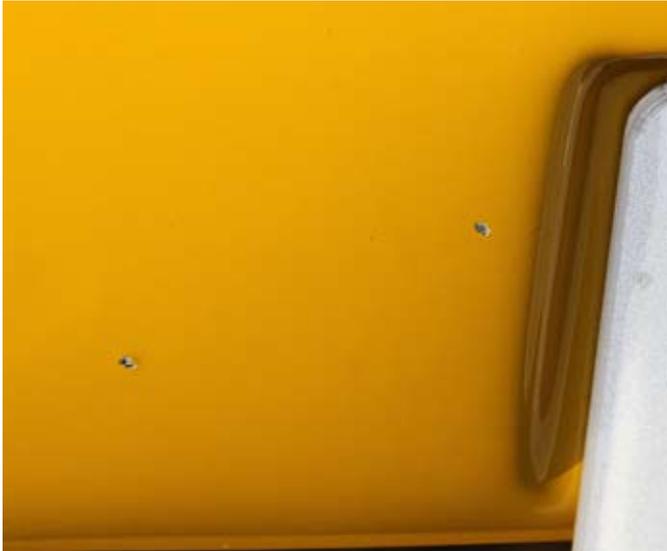
There is no danger of rust on the fibreglass panel, but the proliferation of stone chips was starting to drag down the rest of the car's finish.

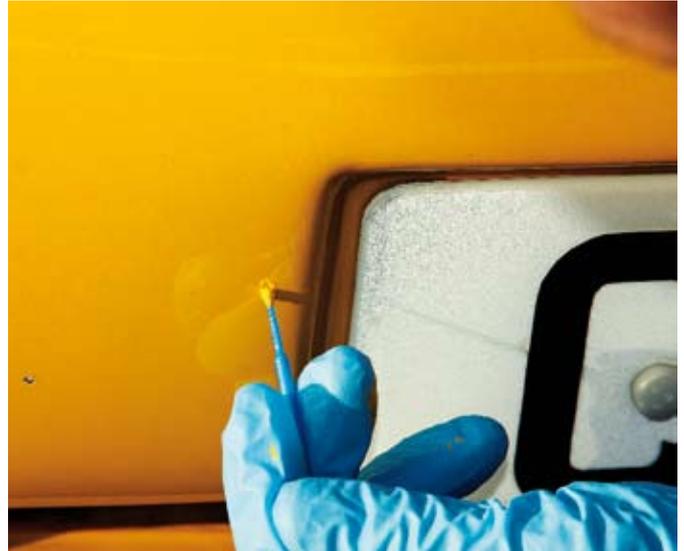
Once you have cleaned the panel, the perfectly matched paint is blobbed into the chip, and dries rapidly – two minutes is all you need for it to set.

area to be treated. You then simply blob the paint onto the stone chip, give it a couple of minutes to dry and then flatten it off with a finger, or the plastic scraper provided in the kit.

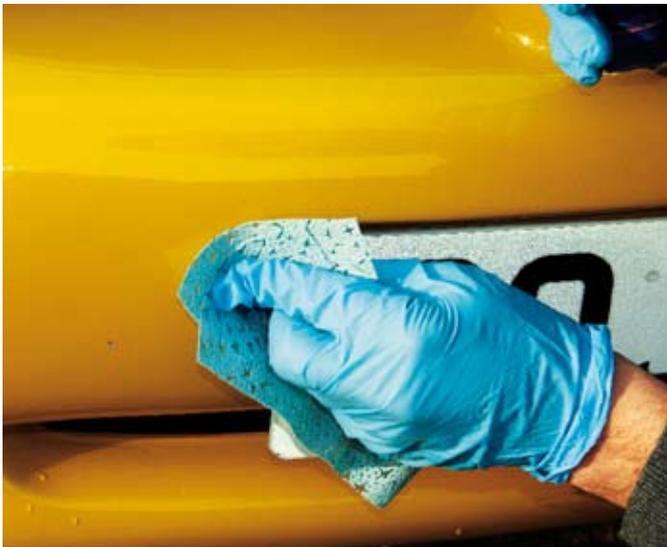
The blending agent then lifts off any excess paint from the panel's surface, leaving the new colour confined within the damaged area.

That is stage one complete. Stage two is to wipe over the painted area using the blending solution from the kit. This lifts off any surplus paint very easily, leaving only the new pigment

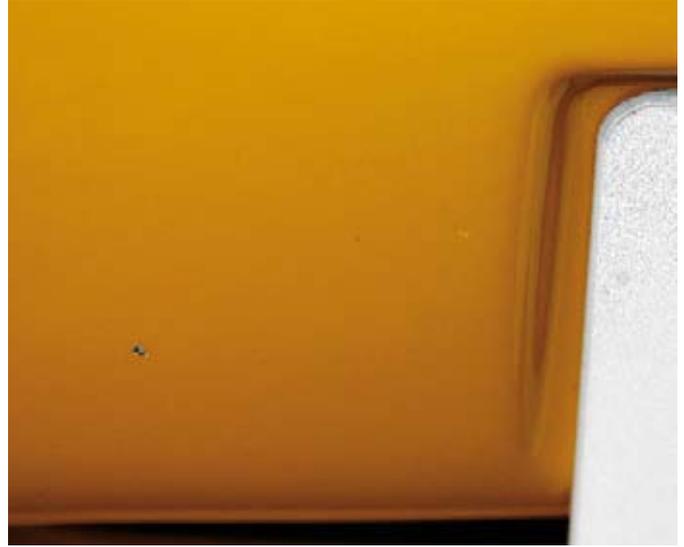
Under the scrutiny of a close-up camera lens you can see where the repair was done, but the chip is all but invisible from a normal viewpoint.

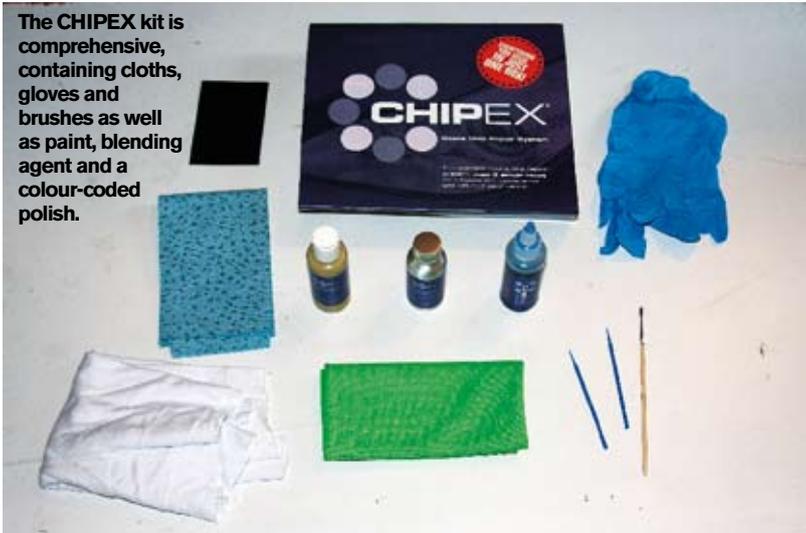
The CHIPEX kit is comprehensive, containing cloths, gloves and brushes as well as paint, blending agent and a colour-coded polish.

The CHIPEX kit costs £49.99, and is pretty comprehensive. You actually get 50ml of paint, which is enough to do a heck of a lot of stone chips! It is not suitable for use with cellulose paints, but is fine with all other types, and that included the two-pack that is now on my car.
